LIEBHERR R914C HD-SL

Year	2008
Hours	11857
Weight	24000
Serial number	WLHZ1063TZC024232
Reference	182263

INSPECTION REPORT

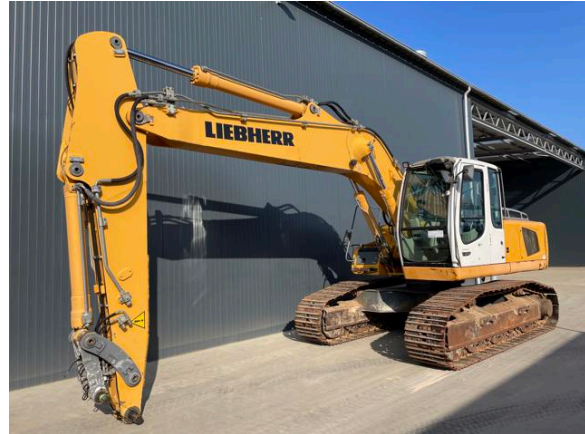
Liebherr R914C HD-SL, Engine brand Liebherr D934, 115kW, EPA, CE, Air conditioning, Central lubrication, Width of the pads 600mm, Mono boom, Piped for hammer & shear, Burst valve on lift cylinder, In good and clean condition.
