CATERPILLAR 320D

Year	2008
Hours	7787
Weight	21800 kg
Serial number	CAT0320DCKGF01220
Reference	181086

INSPECTION REPORT

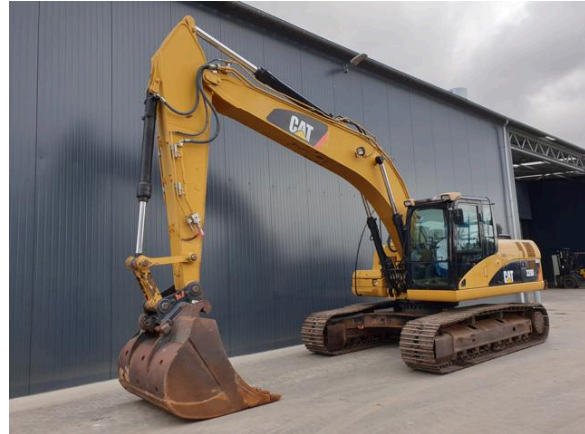
Caterpillar 320D L, Engine brand Caterpillar C6.4, 103kW, CE, Air conditioning, Backup camera, Width of the pads 600mm, Mono boom, Mechanic quick release, Verachttert CW40, Digging bucket with teeth, Width of the bucket 1.50m, Piped for hammer & shear, Burst valve on lift cylinder, Hours certified by Caterpillar, In very good and very clean condition.
