CATERPILLAR 336D LN

Year	2010
Hours	12800
Weight	39400 kg
Serial number	CAT0336DEMYG00198
Reference	181617

INSPECTION REPORT

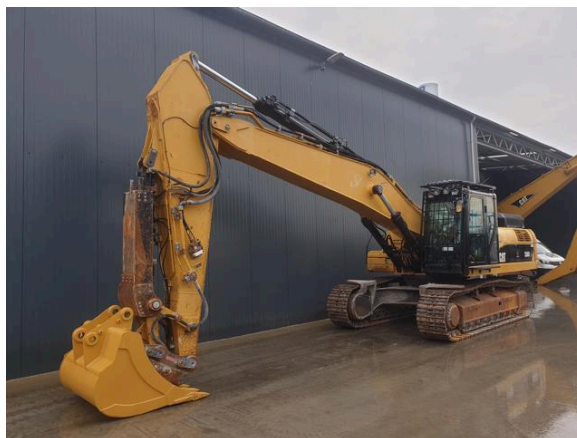
Caterpillar 336D LN, Engine brand Caterpillar C9, 200kW, CE, Emission level Stage IIIA, Air conditioning, Central lubrication, Cabin protection, Cat walk, Width of the pads 600mm, Straight boom, Length of the stick 3.50m, New digging bucket with teeth, Piped for hammer, shear and clamp, Burst valve on lift and stick cylinder, AM/FM Radio, Hours certified by Caterpillar, In very good and clean condition.
