CATERPILLAR D6R XL

Year	2005
Hours	14393
Weight	18050 kg
Serial number	CAT00D6RABLT00271
Reference	180762

INSPECTION REPORT

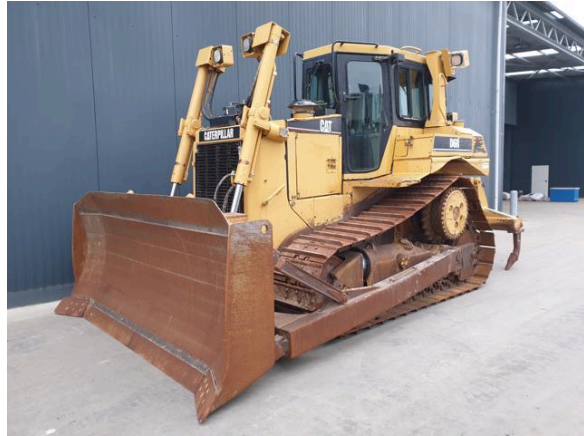
Caterpillar D6R XL, Engine brand Caterpillar C9DI, 138 kW, EPA, CE, Emission level Stage II, Erops cabin, Semi U tilt blade, Width of the blade 3.22m, Differential steering, Multi shank ripper, Width of the pads 610mm, Backup camera, Hours certified by Caterpillar, In very good and clean condition.
