CATERPILLAR 950K HIGH LIFT

INSPECTION REPORT

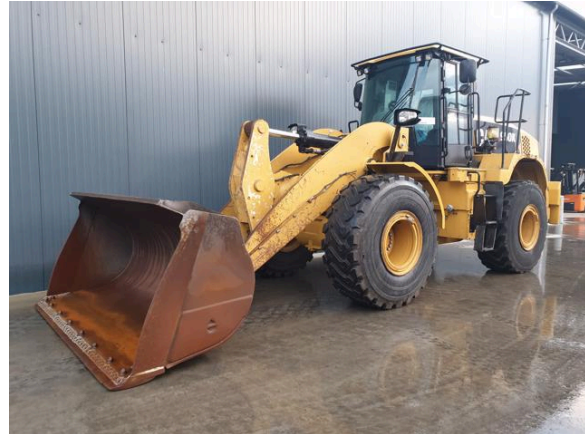
Caterpillar 950K, Engine Caterpillar C7.1, 163kW, EPA, CE, Air conditioning, Erops cabin, 23.5 R25 NEW front tyres, rear tyres 30% good, GP bucket with bolt on edge, Width of the bucket 2.80m, Complete steering wheel, Ride control, Autoshift, Backup camera, Weight load indicator, Central lubrication, Beacon, AM/FM radio, Hours certified by Caterpillar, In very good and clean condition.
