CATERPILLAR M318C

Year	2004
Hours	15848
Weight	19000 kg
Serial number	CATM318CEBCZ00308
Reference	182334

INSPECTION REPORT

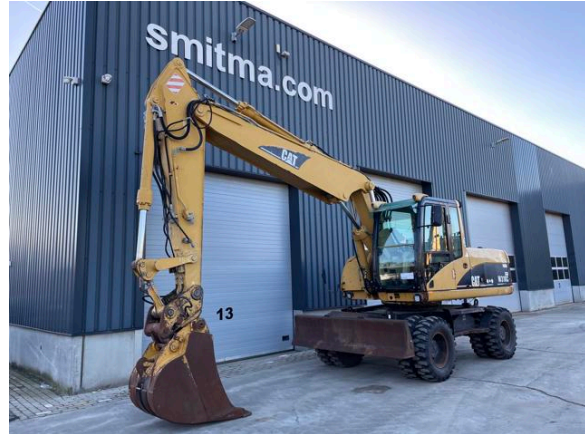
Caterpillar M318C, Engine brand Caterpillar 3056, 118.5kW, CE, Tyre size 10.00 - 20 NEW tyres, V/A boom, Hydraulic quick release, Digging bucket with edge, Width of the bucket 800mm, Piped for hammer & shear, Burst valve on lift cylinder, AM/FM radio, Hours checked by Caterpillar: 19297H, In very good and clean condition.
